# Osgood Property

## LEVEL ONE DOWNSTREAM ANALYSIS

### Sammamish, Washington

Issued: March 22, 2013

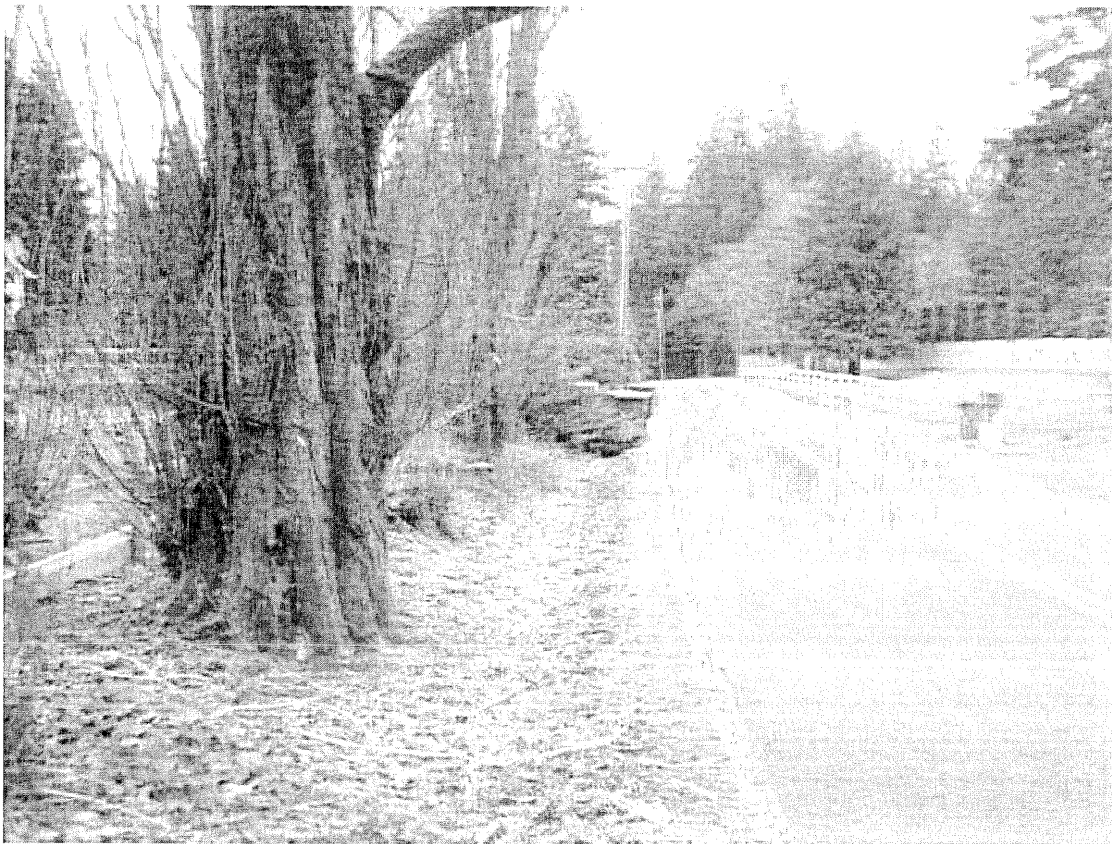
*Photo #1: Looking south along SE 24th Way in front of the site (on the left side).*

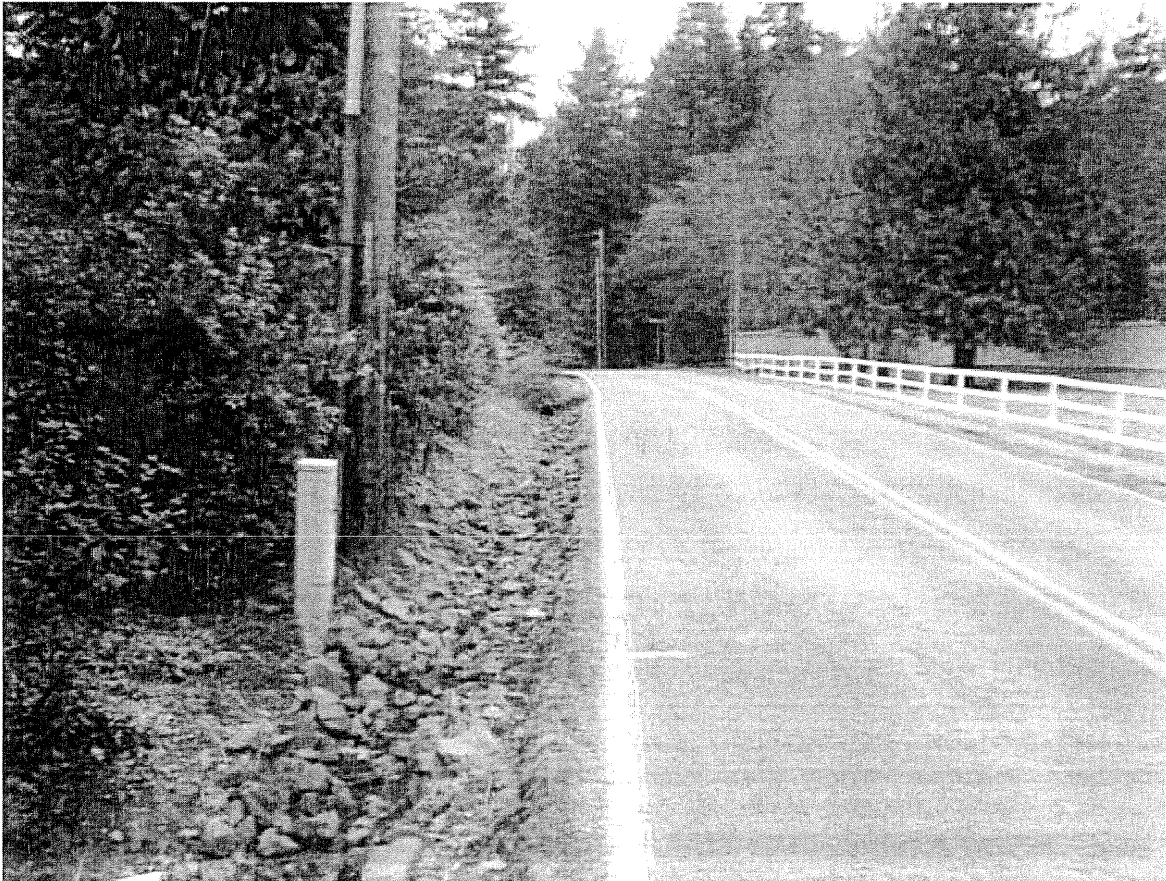
Site runoff sheet flows to the west and exits at the east margin of SE 24th Way. This runoff is collected in a rip-rap armored ditch with 12" culverts at the driveway access points, and directed south along the east margin of SE 24th Way. The average slope of this drainage component is approximately 8%. As seen in the picture below, the ditch is in good condition at the start of this drainage component. The ditch has a 1-foot bottom width, 1- to 2-feet of depth with 1H:1V side slopes. The driveway culvert inlets near the site were free of debris and sediment. This portion of Drainage Component 'A' appeared to be well maintained by the City or adjacent property owners. No signs of erosion or flooding were observed along the upper portions of this drainage component.

*Photo #2: Looking south along the east margin of SE 24th Way. Upper reach of Drainage Component 'A' near the natural discharge location of the site.*

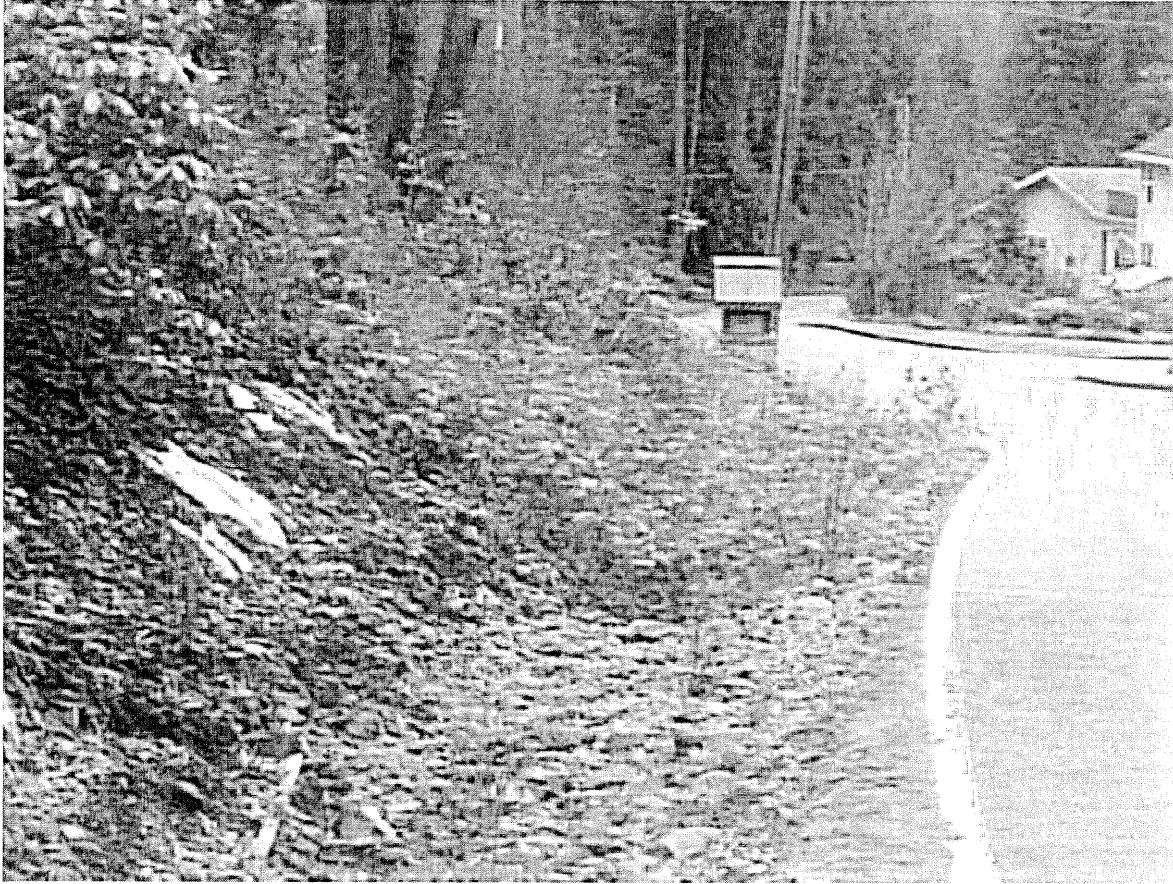
*Photo #3: Looking southwest along the east margin of SE 24th Way,  
near the SE 27th PL intersection.*

The photo above shows Drainage Component 'A', approximately 450-feet from the site. The ditch section at this location is heavily vegetated and has a 1-foot bottom width, 1-foot in depth with 2H:1V side slopes. The rip-rap in the ditch at this location appeared to have settled over time, leaving exposed soil in portions of the ditch. This portion of Drainage Component 'A' did not appear to be regularly maintained by the City or adjacent property owners. Signs of erosion were present due to the lack of rip-rap in portions of the ditch. The driveway culvert inlets at the near this location had minor sediment accumulations. The capacity of the ditch appeared to be reduced due to the amount of vegetation within the ditch section. No signs of flooding were observed at this location.

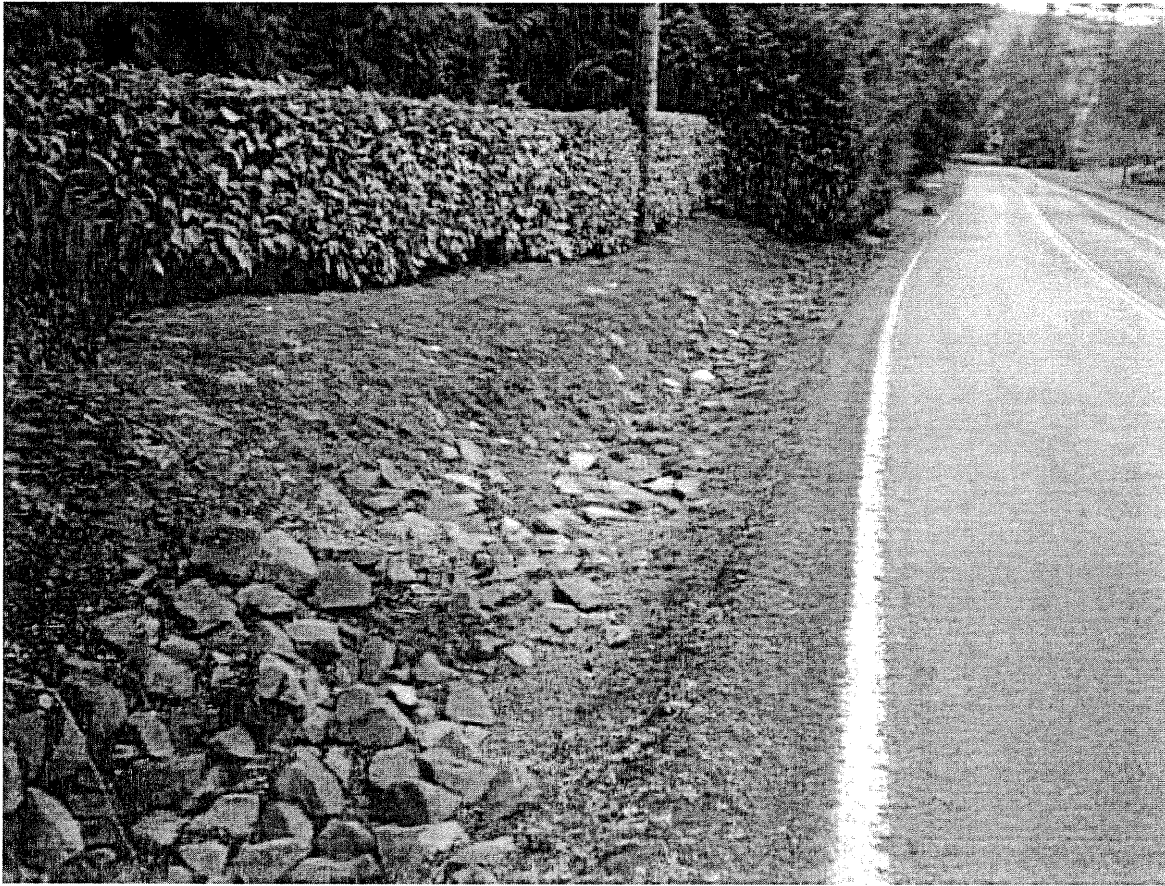
*Photo #4: Looking southwest along SE 24th Way, near the SE 28th PL intersection.*

The photo above shows Drainage Component 'A', approximately 800-feet from the site. The partially rip-rap armored ditch section at this location, has a 1-foot bottom width, 2-feet in depth with 1H:1V side slopes. The capacity of the ditch appeared to increase relative to the original capacity near the upper portion of this drainage component. The rip-rap in the ditch at this location was in good condition and appeared to be regularly maintained by the City or adjacent property owner. No signs of flooding or erosion were observed at this location.

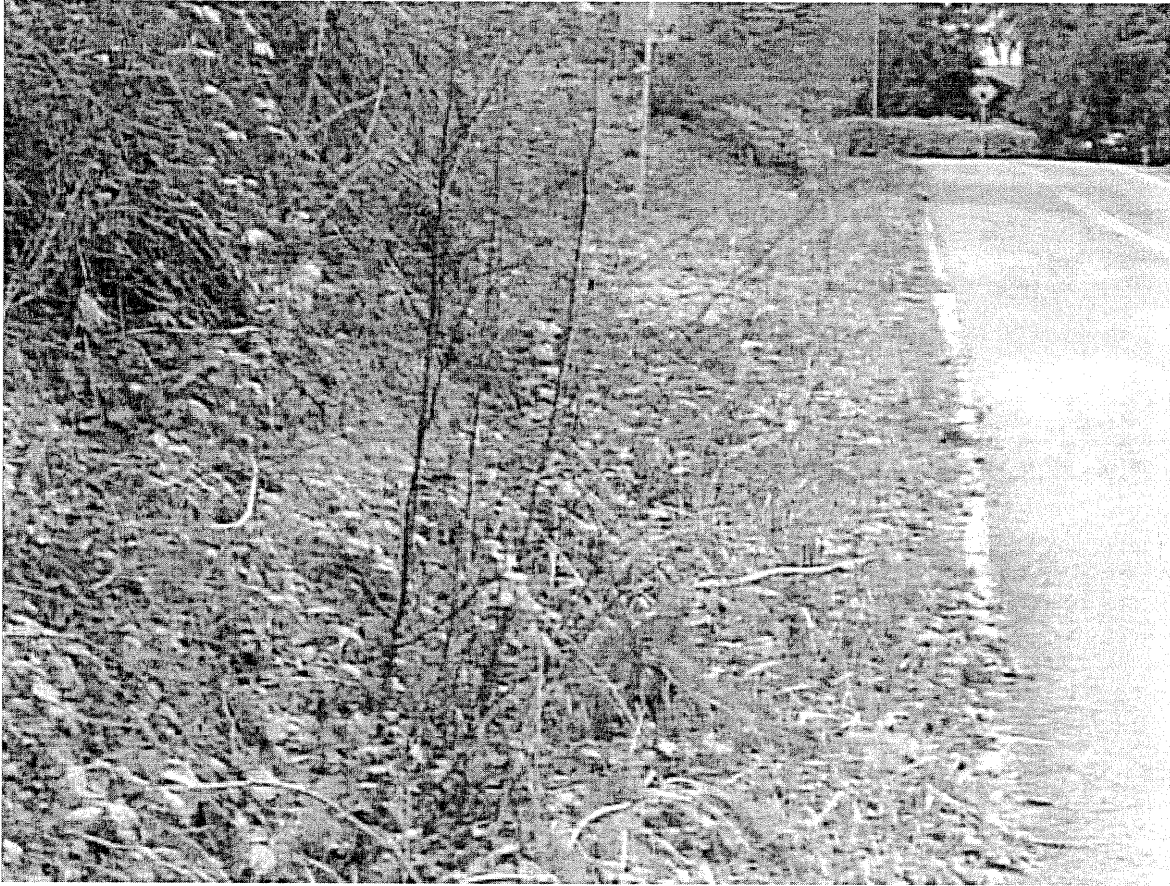
*Photo #5: Looking southwest along SE 24th Way.*

The photo above shows Drainage Component 'A', approximately 1,200-feet from the site. The ditch section at this location has a 1-foot bottom width, 1-foot depth with 1H:1V side slopes. The rip-rap in the ditch at this location was not visible due to the heavy vegetation. The driveway culvert inlets at the near this location had minor sediment accumulations. Sediment accumulations could be the result of adjacent gravel/dirt driveway entrances. The capacity of the ditch appeared to be reduced due to the amount of vegetation within the ditch section. This portion of Drainage Component 'A' did not appear to be regularly maintained by the City or adjacent property owner. No signs of flooding were observed at this location.

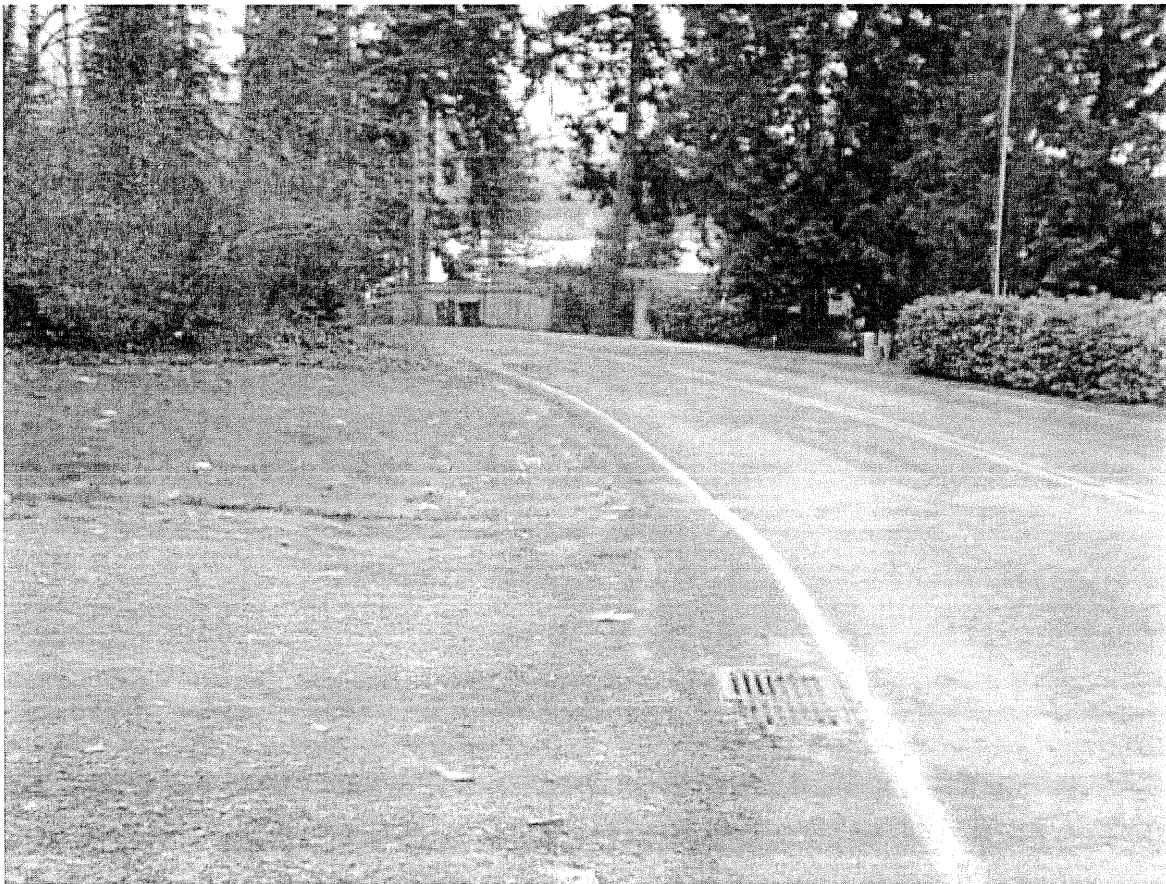
Runoff from Drainage Component 'A' enters an 18" pipe and catch basin system, approximately 1,425-feet from the site, near the intersection of SE 24th Way and 194th Avenue SE. The inlet into Drainage Component 'B' had minor sediment accumulation from Drainage Component 'A'. The catch basin rim near the intersection was compacted with gravel/dirt from the adjacent gravel driveway located at 19401 SE Way. It appears that this gravel/dirt is the result of loose debris from the driveway and not a result of the upstream drainage system. The average ground slope of this drainage component is approximately 16%. Minor sediment accumulations and about 1-foot of standing water were observed in the catch basin sumps. Photo's #6 (below), #7 and #8 (next page) show Drainage Component 'B' going towards Lake Sammamish. No visible signs of flooding were observed.

*Photo #6: Looking southwest along the southeast margin of SE 24th Way,  
near the intersection of 194th Ave SE.*

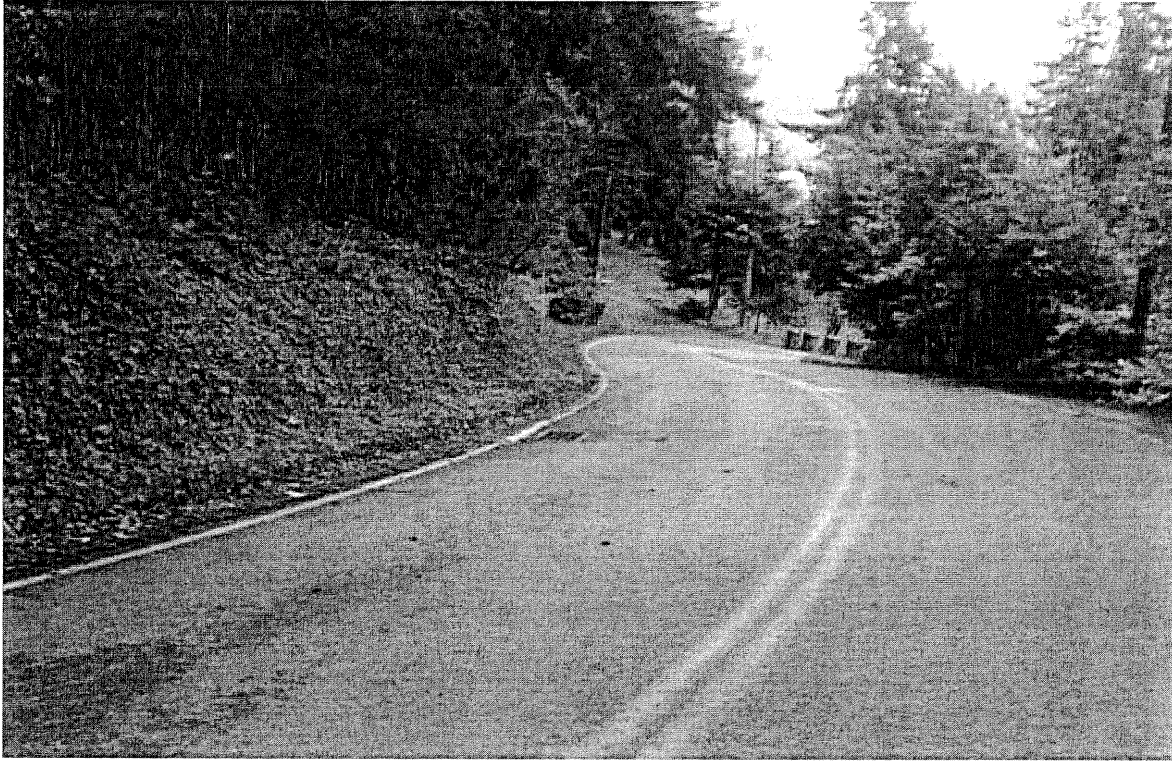
*Photo #7: Looking south along SE 24th Way.*

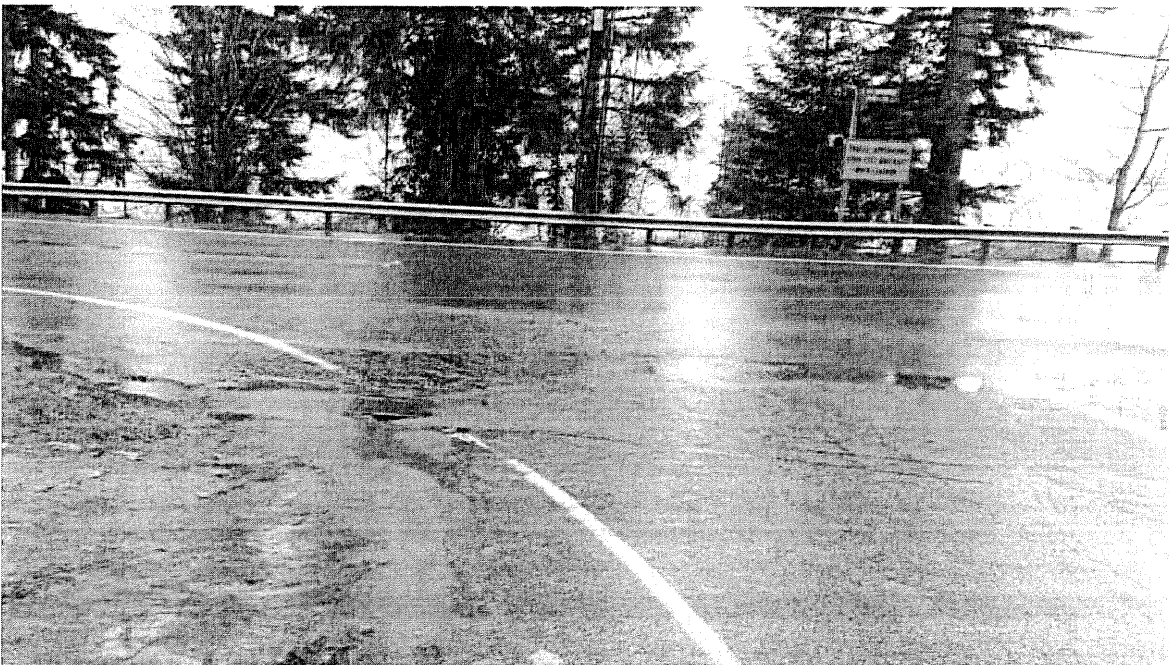
*Photo #8: Looking southwest at the intersection of  
SE 24th Way and East Lake Sammamish Pkwy SE.  
(Photo taken on a rainy day in the beginning of February 2013).*

From Drainage Component 'B', runoff enters the catch basin (show in Photo #8) near the intersection of SE 24th Way and East Lake Sammamish Pkwy SE. Drainage Component 'C' starts at the catch basin near the intersection. Runoff is directed to the southeast along the northeast margin of East Lake Sammamish Pkwy SE in a 24" pipe and catch basin system. The average slope of this drainage component is approximately 3%. Minor trash debris accumulation was observed near the catch basin inlets. No visible signs of erosion or flooding were observed.

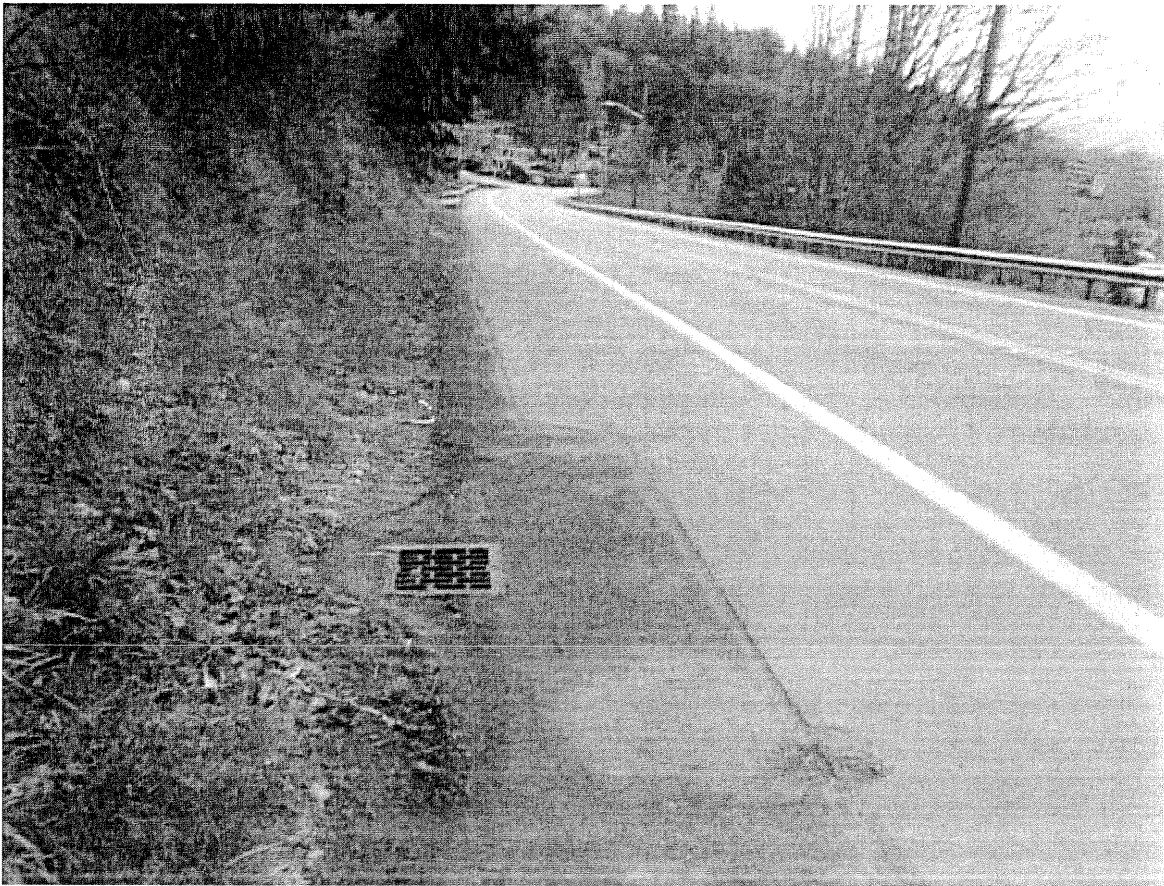
*Photo #9: Looking east along East Lake Sammamish Pkwy SE.*

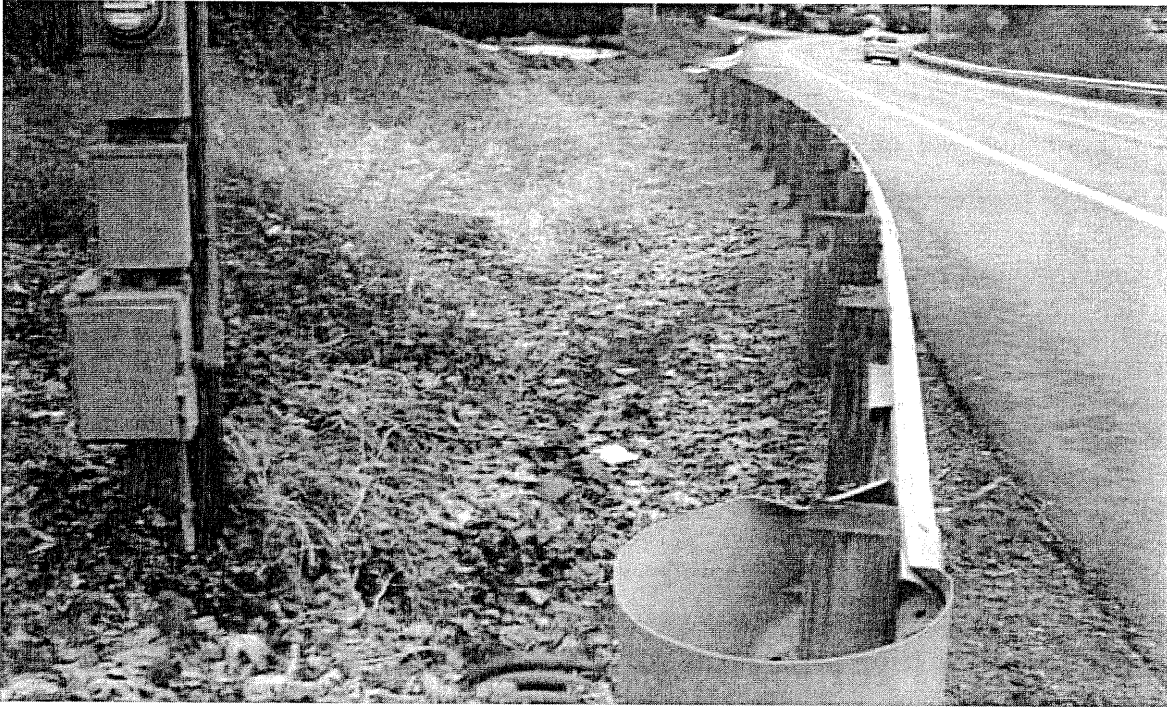
Runoff from Drainage Component 'C' enters a drainage swale located on the northeast margin of East Lake Sammamish Pkwy SE. Minor trash debris and sediment accumulation

were observed at the inlet and outlet of the drainage swale. This drainage swale has well establish vegetation consisting of tall grass/weeds. The swale had a 5-foot bottom width, 15- to 20-foot top width and was approximately 6-feet below the adjacent road. The average slope is approximately 2%. No signs of flooding were observed.

*Photo #10: Looking east along East Lake Sammamish Pkwy SE at the inlet.*

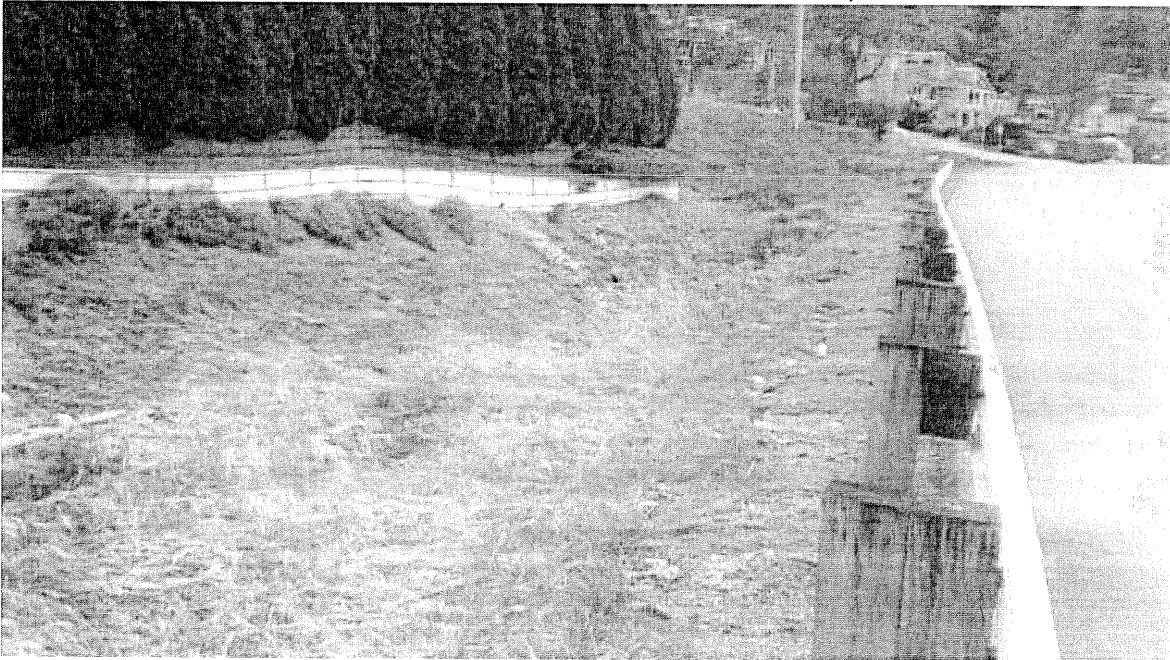
*Photo #11: Looking east along East Lake Sammamish Pkwy SE.*

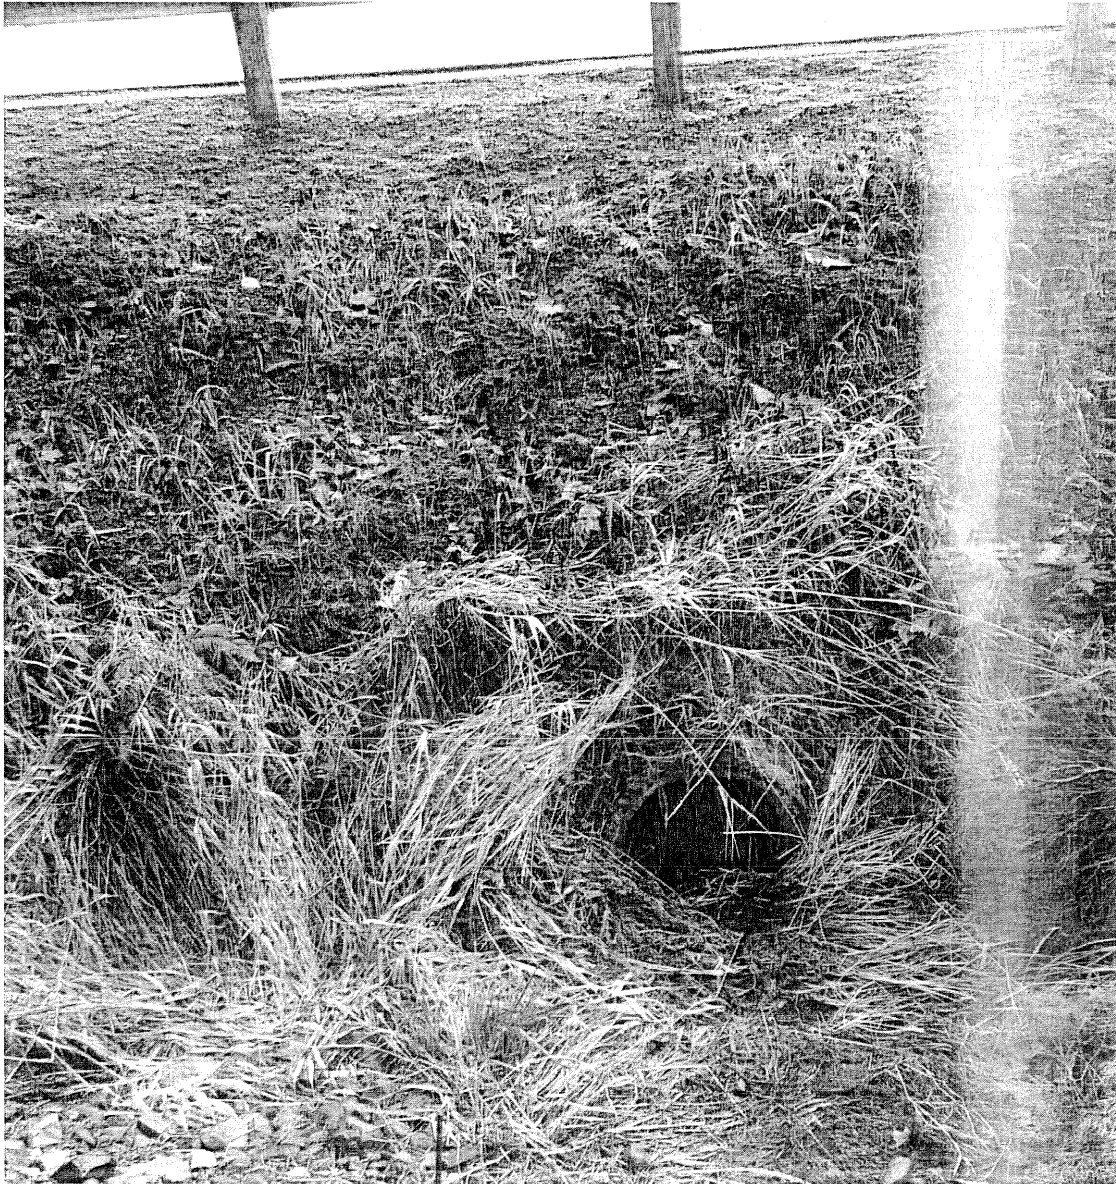
Runoff exits the drainage swale and enters a 24" pipe and flows south, crossing under East Lake Sammamish Pkwy SE. This drainage component shown below was approximately 2,625-feet downstream of the site. The 24" pipe inlet was surrounded by well-established vegetation with minor sediment accumulation. The average slope of this drainage component is approximately 2% and the pipe outlet (on the south side of the East Lake Sammamish Parkway SE) discharged to a rip-rap pad. No signs of flooding were observed.

*Photo #12: Looking south at the inlet of Drainage Component 'E' that crossing under East Lake Sammamish Pkwy SE.*

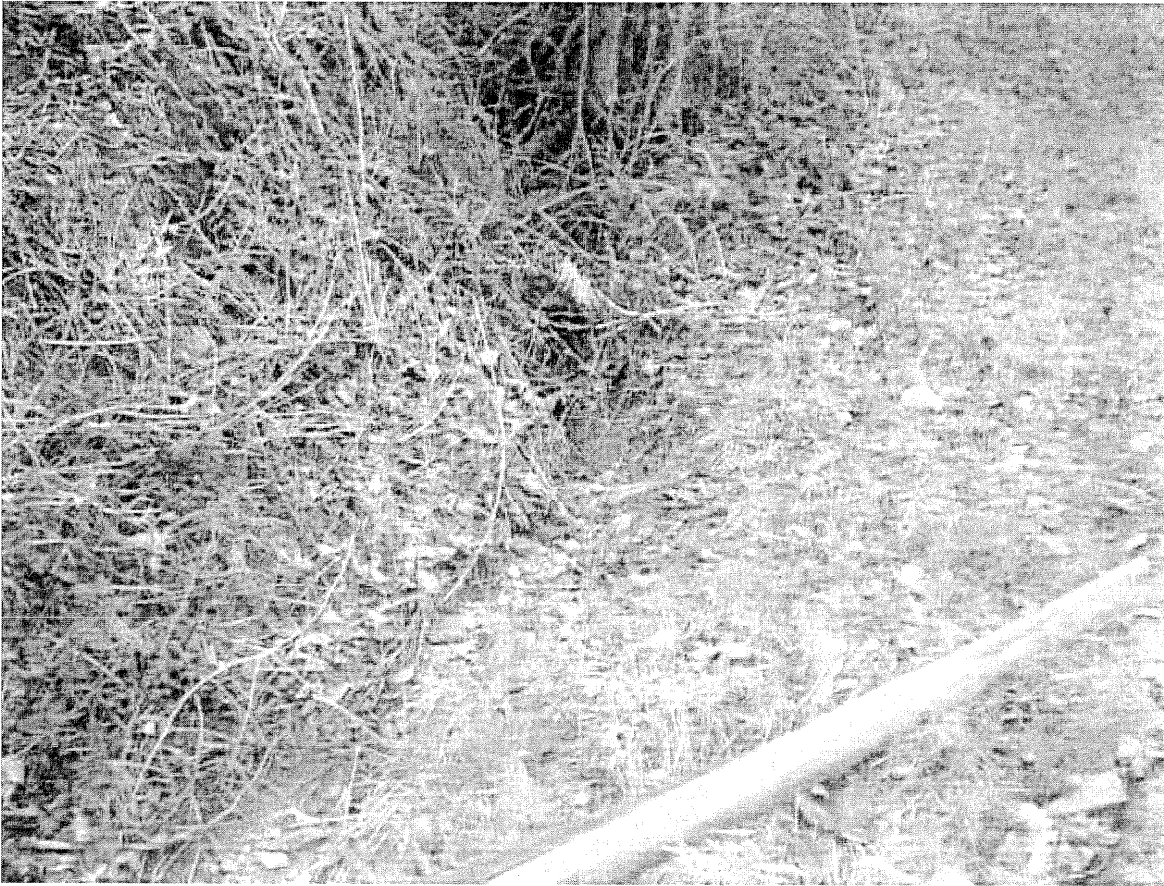
Runoff from Drainage Component 'E' outlets south of East Lake Sammamish Pkwy SE to a gravel channel. Drainage Component 'F' consists of a meandering gravel channel with 1-foot bottom width and less than 1-foot deep. The average slope of Drainage Component 'F' is approximately 20%. The majority of this drainage component was not accessible due to thick vegetation and relative steep slope. The end of this gravel channel appeared to have settled over time, leaving exposed soil in portions of the gravel channel. Signs of erosion were present due to the lack of gravel in the channel. This portion did not appear to be regularly maintained by the City or others. No signs of flooding were observed.

*Photo #13: Looking northeast, near the outlet of Drainage Component 'F'.  
Surface water flows to the bottom left corner of the picture.*

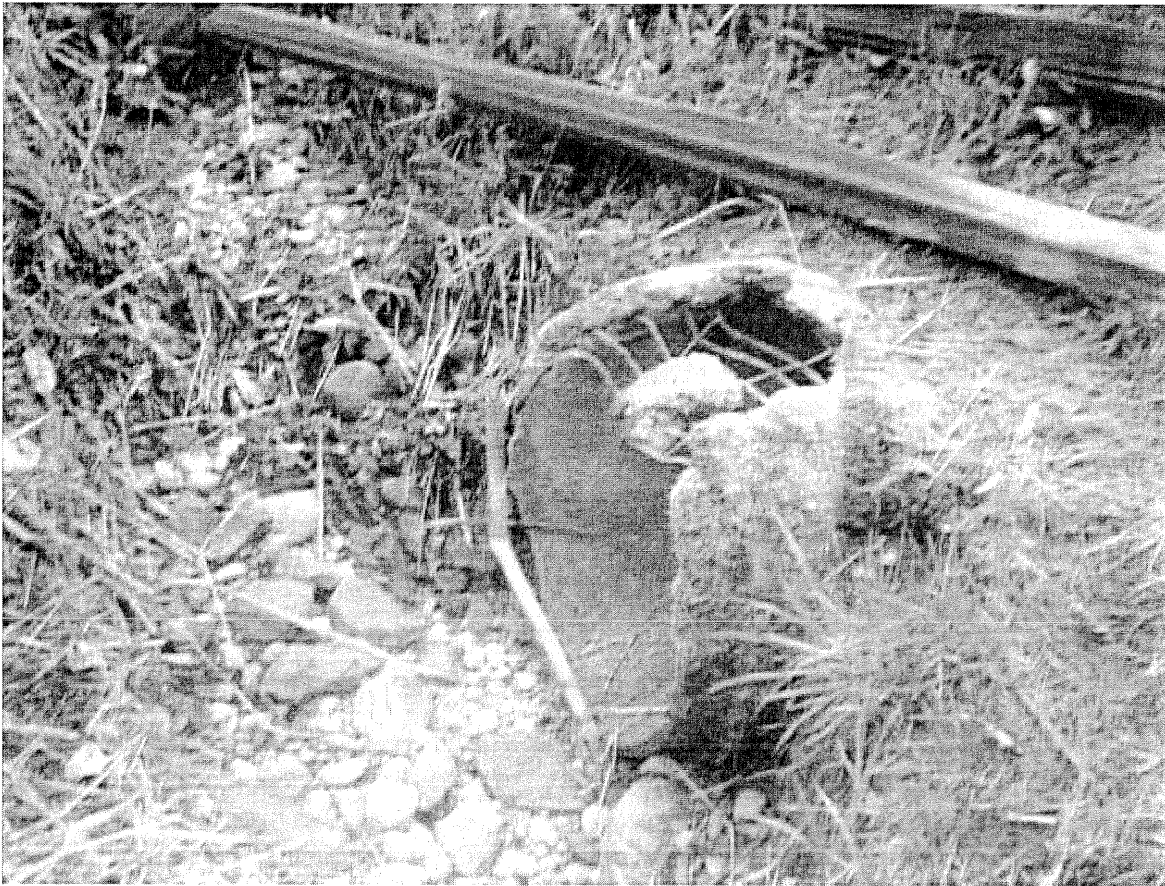
Runoff from Drainage Component 'F' enters a 24" concrete pipe and directs runoff south under the East Lake Sammamish Trail. Minor vegetation and sediment accumulation was observed at the inlet. The 24" pipe inlet was damaged but still functional. The average slope of this drainage component is approximately 2%. The pipe outlet on the south side of the Trail, discharged to a sheet of black plastic, anchored underneath the pipe (see photo #15). The pipe outlet of did not appear to be regularly maintained by the City or others. No signs of flooding were observed.

*Photo #14: Looking at inlet of 24" pipe that crosses under East Lake Sammamish Trail.*

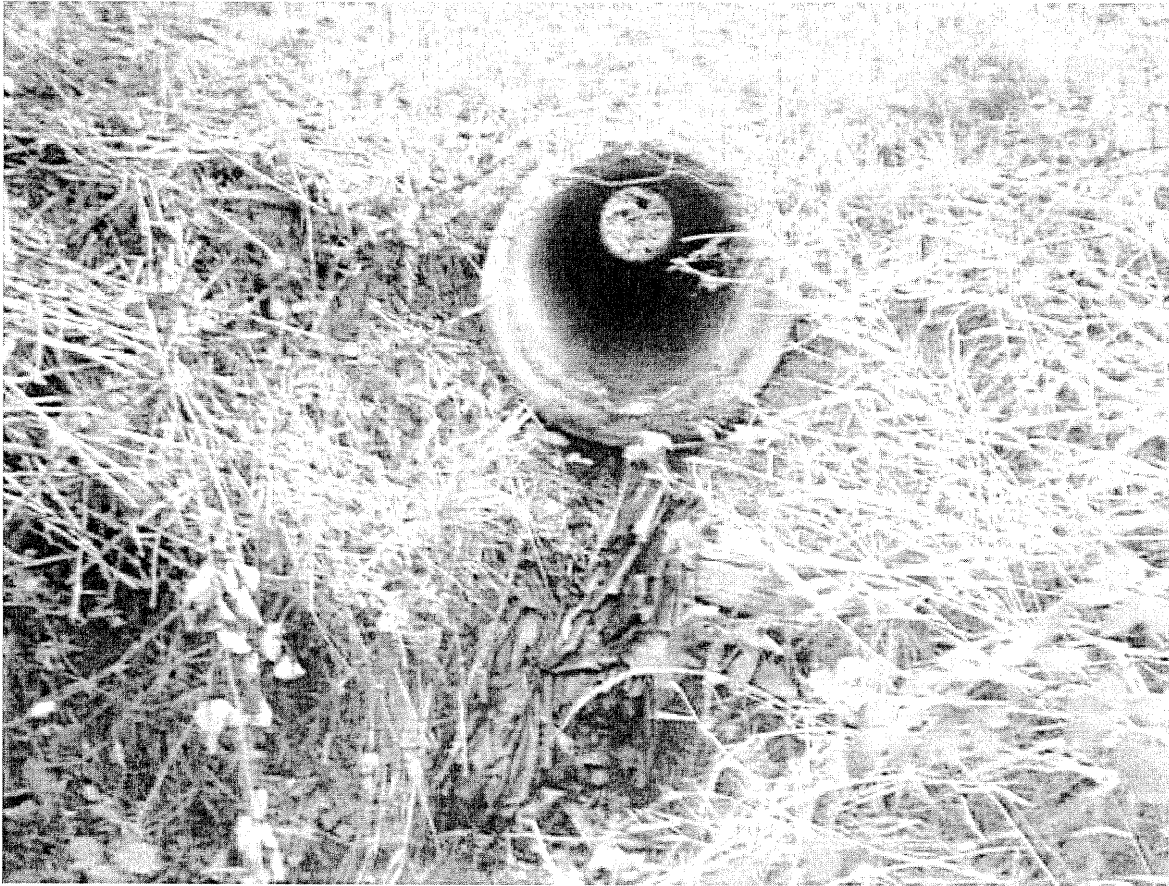
*Photo #15: Looking to the northeast at the outlet of the 24" pipe that crosses under the East Lake Sammamish Trail.*

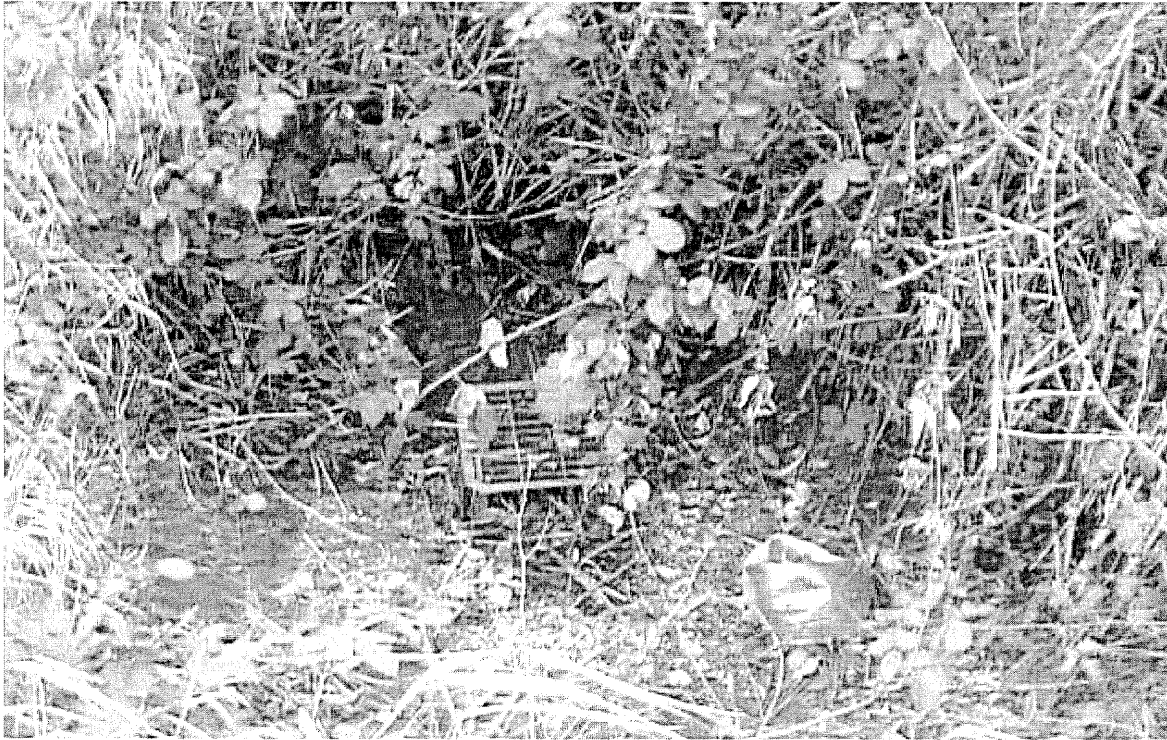
Runoff from Drainage Component 'G' outlets to the south and enters a catch basin (see Photo #16). This catch basin outlets to the southwest into Lake Sammamish through an 18" pipe. The catch basin inlet was surrounded by heavy vegetation and moderate sediment accumulation. Standing water was observed at the invert of the inlet pipe in the catch basin. Access to the outlet of this pipe was restricted due to no trespassing signs on the adjacent private beach area. From the direction of the pipe orientation in catch basin, it appeared that the pipe outlet is in a rock bulkhead, north of the private beach, into Lake Sammamish. This is the last drainage component of the Study Area. Lake Sammamish is listed on the WSDOE 303d List of Polluted Waters for having Total Phosphorus (category 2), Bacteria (category 5) and Dissolved Oxygen (category 5) problems. See Section 5 for mitigation of these existing water quality problems.

*Photo #16: Catch basin inlet of Drainage Component 'H'.*

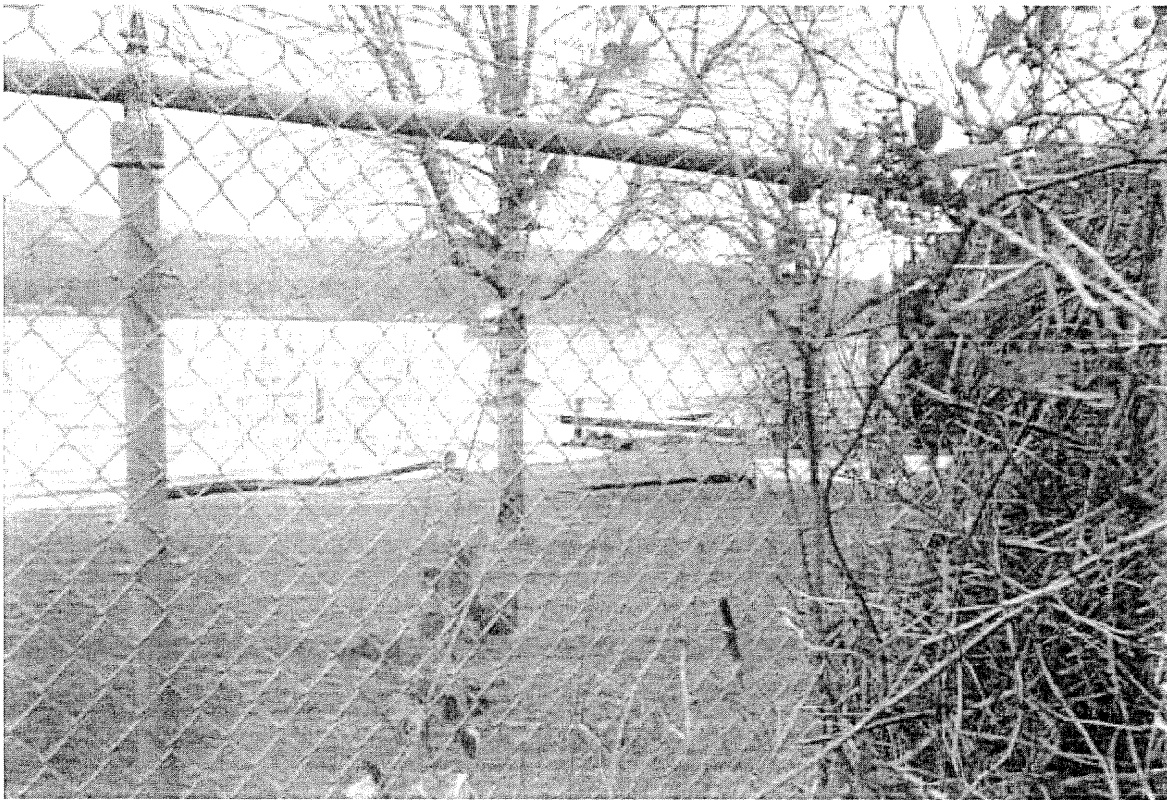
*Photo #17: Looking southwest at Lake Sammamish,  
from the catch basin shown in Photo #16.*
